BEHAVIOR OF LIGHTWEIGHT WALL PANELS AGAINST BLAST

ARIE BOIMEL M.Sc. Civil Engineer

TAAS -Israel Industries
P.O.Box 1044, Ramat-Hasharon, ISRAEL

TWENTY-SIXTH DOD EXPLOSIVES SAFETY SEMINAR
DORAL RESORT & COUNTRY CLUB, MIAMI, FLORIDA
16 - 18 AUGUST 1994

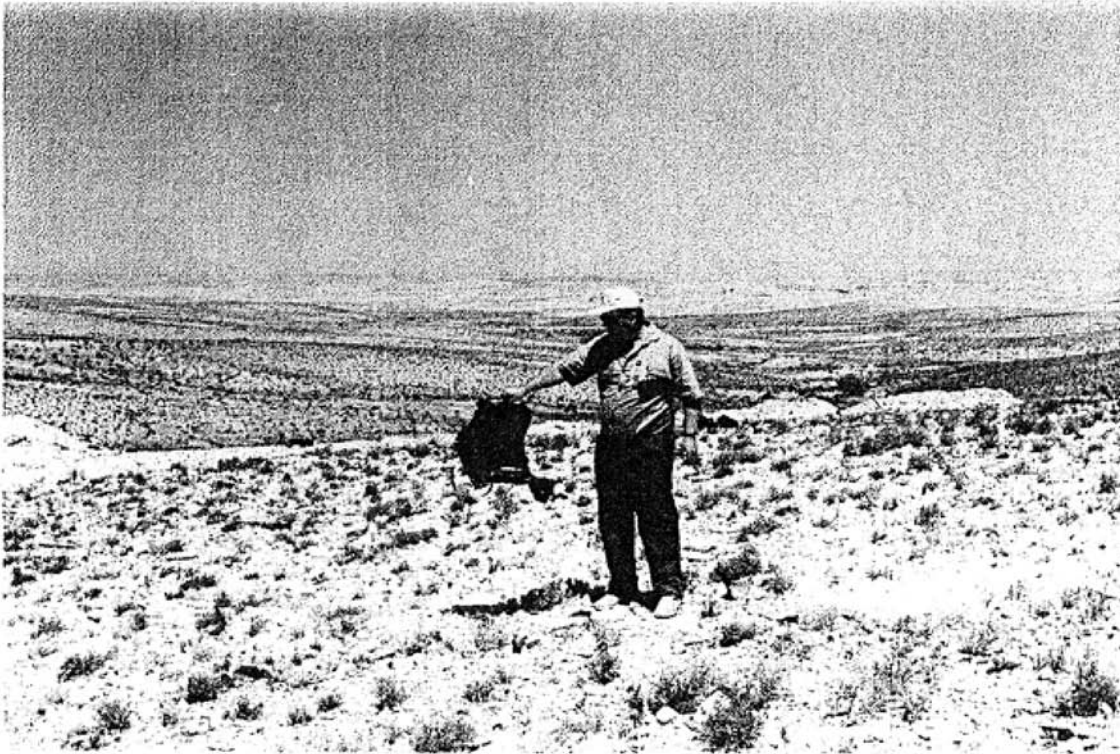
PICTURE 4.: METAL FRAGMENT FROM THE 10M WALL PANEL.

Picture 4: Metal fragment from the 10m wall panel.

The metal sheet was shattered to 50 pieces. The big fragments were twisted and deformed in a way that it was impossible to measure their exact size, and only a rough estimation was made.

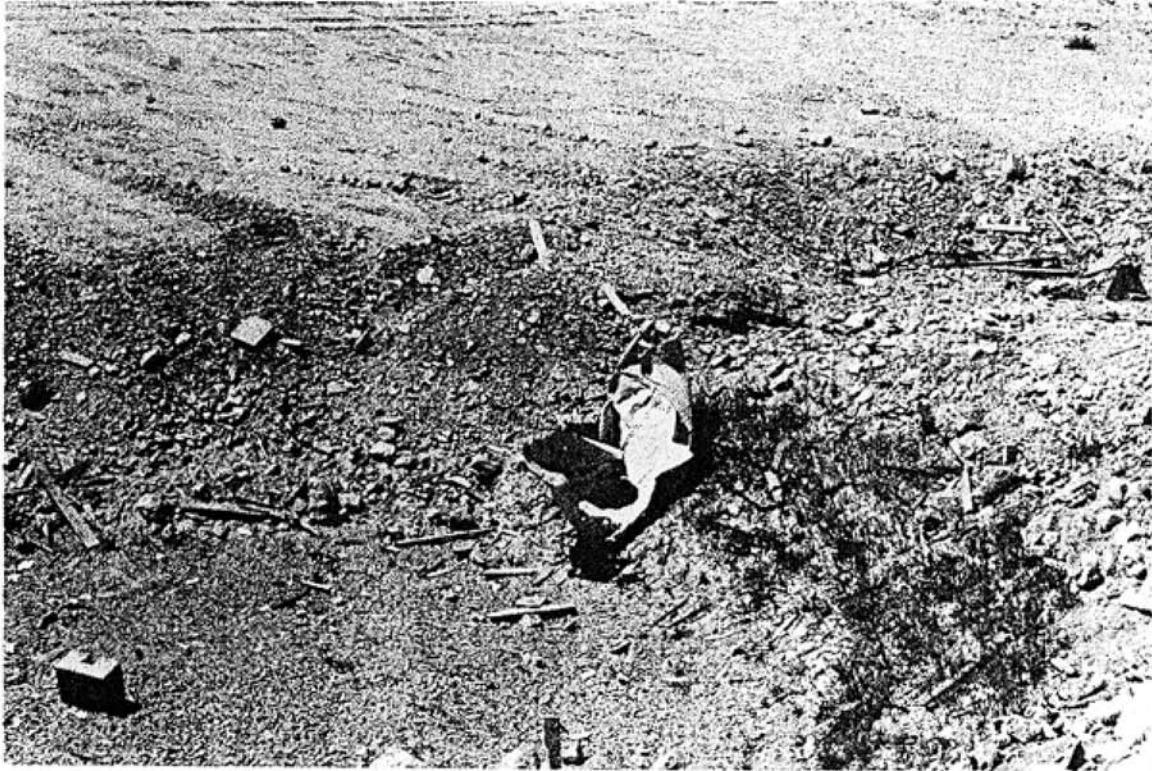
PICTURE 6.:
METAL SHEET 27M FROM WALL PANEL, 20M FROM C.O.E.

Picture 6: Metal sheet 27m from the wall panel, 20m from C.O.E.

The metal sheet panel flew as one twisted piece and was found 27 m' from its original location.

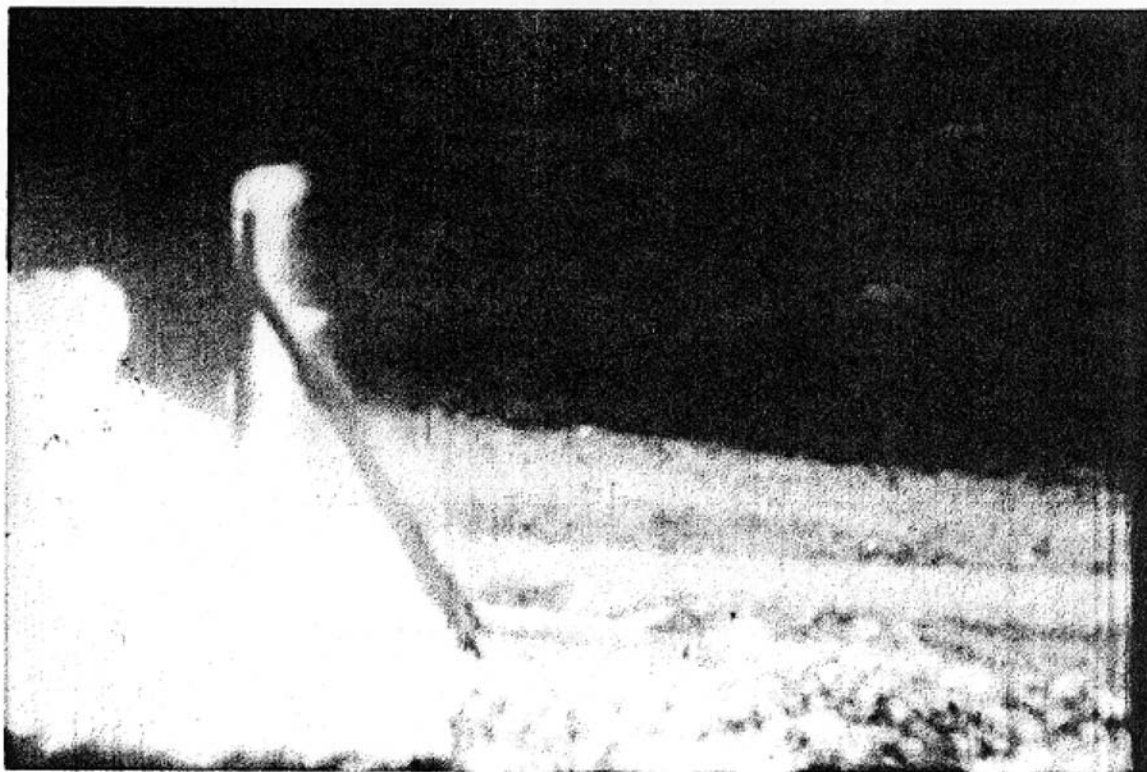
**PICTURE 11.: 10 MSEC AFTER EXPLOSION (HIGH SPEED
CAMERA)**

Picture 11: 19 msec after the explosion

From data obtained by developing of the high speed camera's film , we could evaluate the initial velocity of the fragments to be between 50 and 140 m./sec.,with launching angle of less then 30 deg..
